Contract #: 04-0120F4Cty: SF/ALA Rte: 80 PM: 13.2/13.9File #: 69.28**WELDING INSPECTION REPORT****Resident Engineer:** Pursell, Gary**Address:** 333 Burma Road**City:** Oakland, CA 94607**Report No:** WIR-008918**Date Inspected:** 14-Sep-2009**Project Name:** SAS Superstructure**OSM Arrival Time:** 700**Prime Contractor:** American Bridge/Fluor Enterprises, a JV**OSM Departure Time:** 1900**Contractor:** Zhenhua Port Machinery Company, Ltd (ZPMC), Changxing Island **Location:** Shanghai, China**CWI Name:** Chen Xi**CWI Present:** Yes No**Inspected CWI report:** Yes No N/A**Rod Oven in Use:** Yes No N/A**Electrode to specification:** Yes No N/A**Weld Procedures Followed:** Yes No N/A**Qualified Welders:** Yes No N/A**Verified Joint Fit-up:** Yes No N/A**Approved Drawings:** Yes No N/A**Approved WPS:** Yes No N/A**Delayed / Cancelled:** Yes No N/A**Bridge No:** 34-0006**Component:** OBG Crossbeams**Summary of Items Observed:**

OBG CROSS BEAM CB14

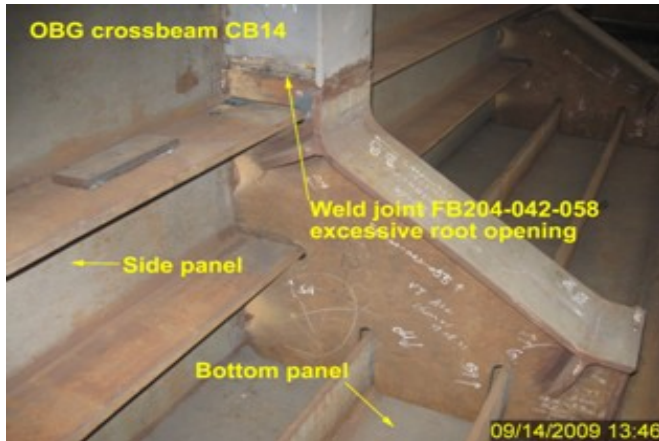
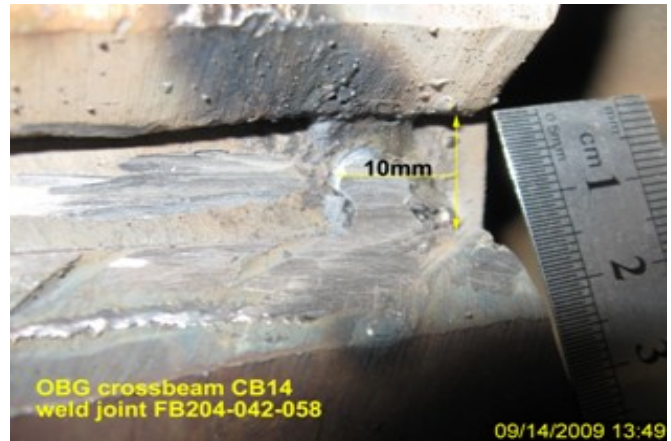
During random in process visual inspection of weld joint fit up this QA observed that CJP weld joint identified as CB204-042-058 has a root opening of approximately 10mm. This exceeds the 5mm allowed per the applicable WPS. QA observed that the contractor has tack welded a backing bar on this joint. According to weld detail drawing WD60M this joint is not designed with a backing bar. The contractors CWI for this bay was not available for comment concerning this issue during the time QA was present. See attached photos.
